Seasonal Progress Report #3
SR431 Treatment Vault Effectiveness Monitoring

Agreement Number: P423-13-019

Submitted by: Tahoe Resource Conservation District

Period: Summer Season, June 1 – September 30, 2016

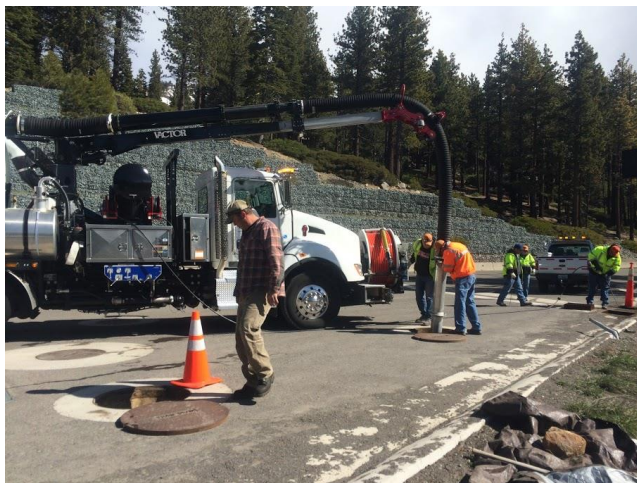
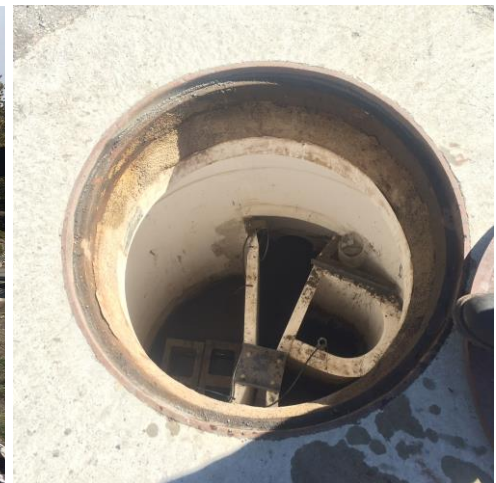
Vector truck cleanout on 4/15/16 at SR431 (left). Note accumulated sediment along the curb. Sediment filled flume prior to cleanout (right).

Looking forward to the summer season, Tahoe RCD staff measured the depth of accumulated sediment in the Contech MFS vault at 0.75 feet on June 3, 2016. NDOT was notified immediately. On June 21 and 22, 2016 the NDOT maintenance crew was scheduled to:

- Vactor sediment from both treatment vaults
- Replace the cartridges in the Contech MFS
- Remove and clean the filters on the Jellyfish or remove and replace with the clean ones

However, Tahoe RCD staff was notified on the morning of June 21 that due to confined space issues the above described maintenance was on hold until further notice. Maintenance was rescheduled for August 3, 2016 at which time the crew cleaned out the Contech MFS vault and replaced the cartridges. The rest of the maintenance had to be postponed again due to a malfunction of the vactor truck. Event sampling for the summer season did not resume because the completion of the maintenance on the system did not occur during the summer season. The maintenance described above (with the exception of vactoring sediment from the Contech MFS and replacing the cartridges) has been scheduled for October 20, 2016, after which the instrumentation will be checked and recalibrated within a week of maintenance and event sampling will resume.

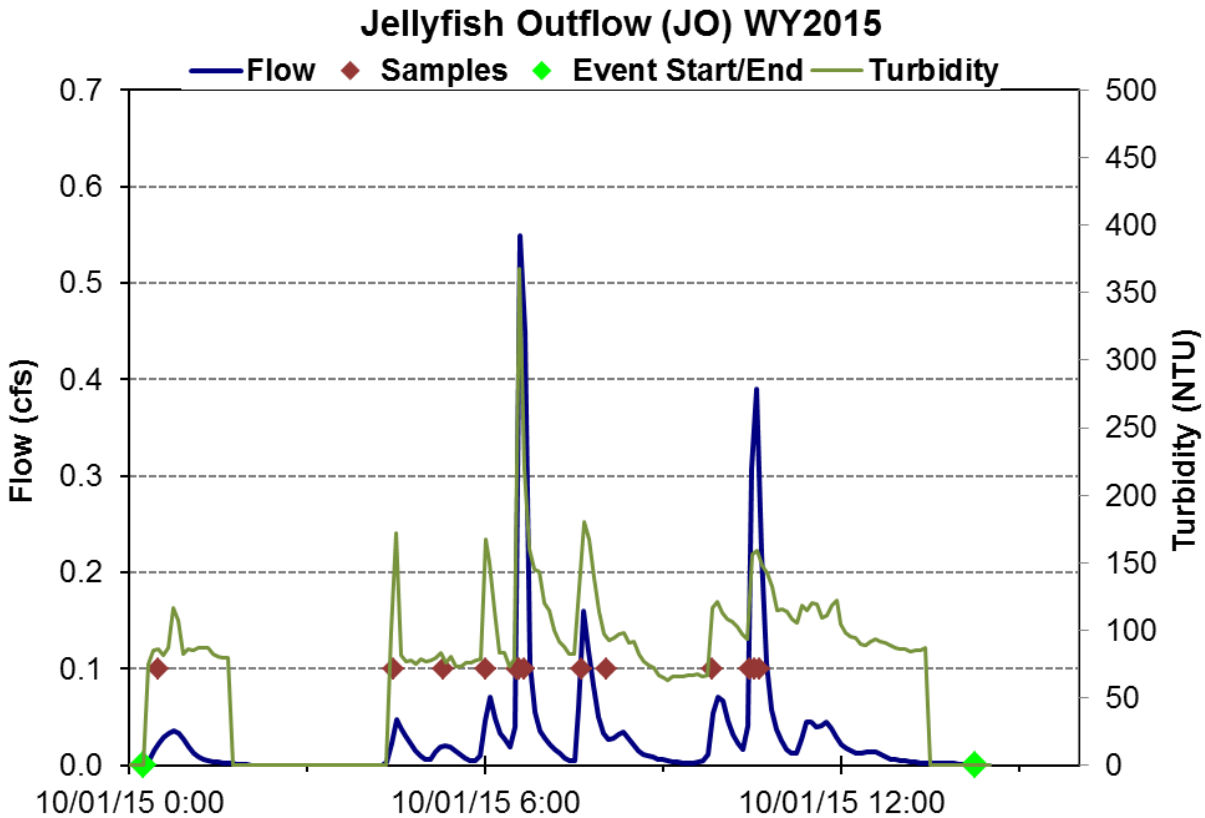
Figure 4: Hydrograph, continuous turbidity and sample distribution at the Jellyfish outflow for the 10/1/15 thunderstorm event.

See Figures 1-16 below for hydrographs, continuous turbidity and sample distributions for each of the four events sampled in the fall/winter season and Figures 17-24 for each of the two events sampled in the spring season. As mentioned previously, no events were sampled during the summer season due to sediment accumulation on the sensors and intake tubes. Hydrographs at this site are generally very spikey, likely due to the high percentage of impervious area in the catchment. The high imperviousness causes sites to respond quickly to rapidly fluctuating precipitation intensity which causes the spikes in the flow data. In general, turbidity stays high for the duration of the event as opposed to peaking at the beginning of the event and tapering off. This is likely due to the fact that the dominant land use is primary road, which may be a constant source of sediment. It is interesting to note that during the 1/29/16 event, all sites did experience an initial pulse of turbidity that gradually tapered off. This could indicate that traction abrasives were applied to the highway for the icy conditions of January and were quickly washed off with the rain.

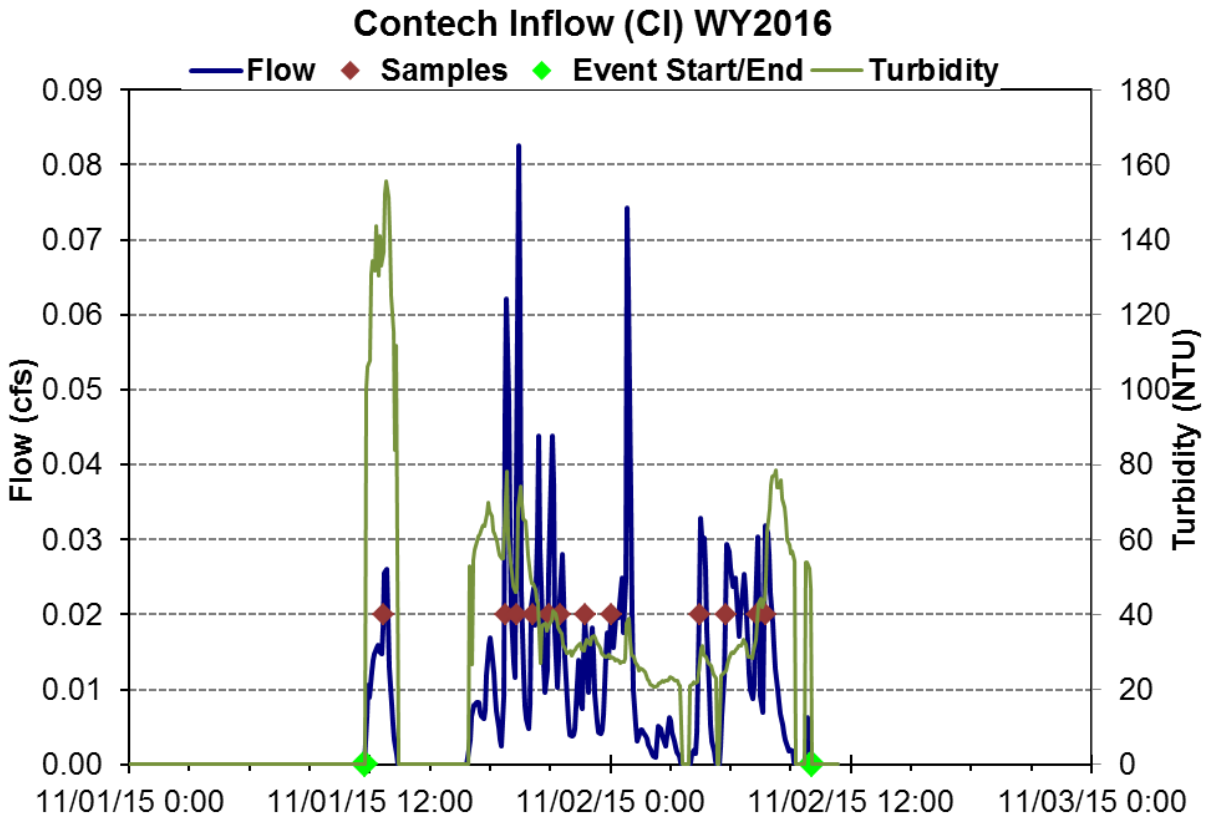
Figure 5: Hydrograph, continuous turbidity and sample distribution at the Contech MFS inflow for the 11/1/15 rain and snow event.

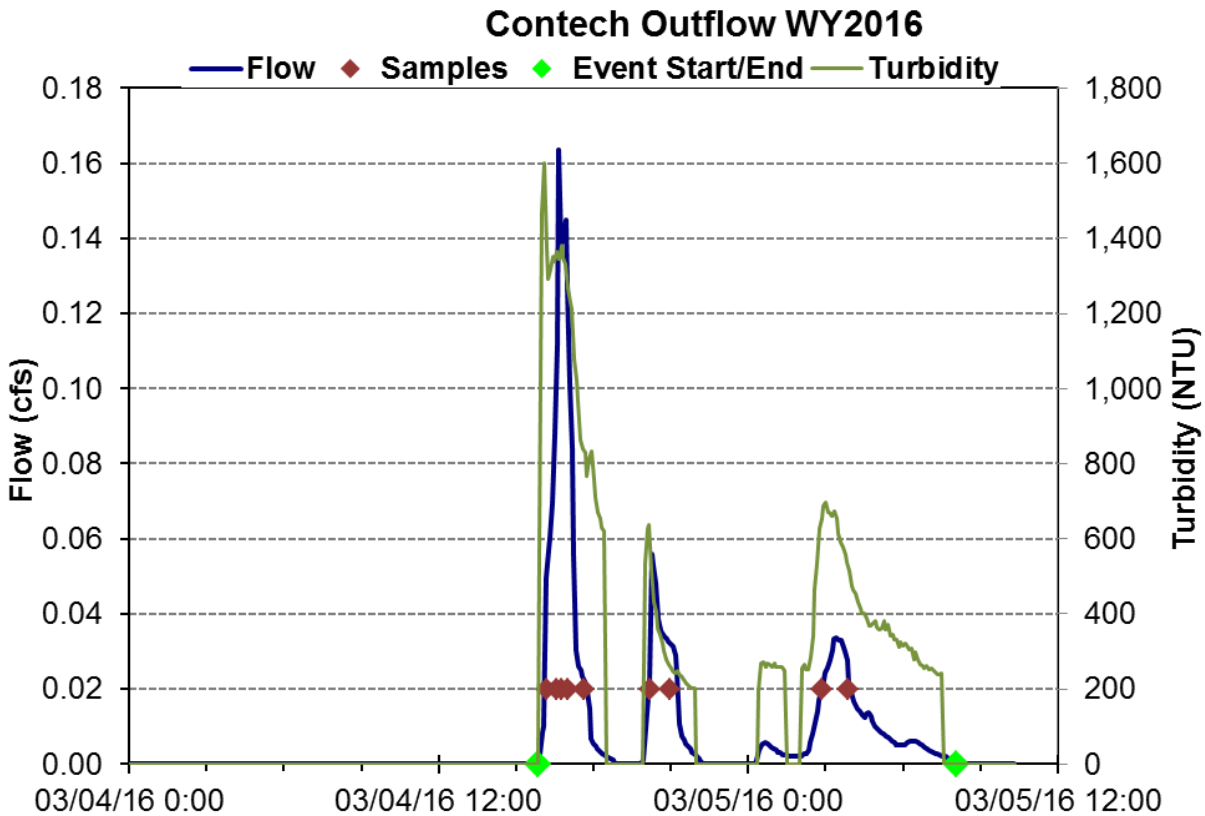
Figure 18: Hydrograph, continuous turbidity and sample distribution at the Contech MFS outflow for the 3/4/16 rain event.
