Seasonal Progress Report #5

SR431 Treatment Vault Effectiveness Monitoring

Submitted by: Tahoe Resource Conservation District

Period: Spring Season, March 1, 2017 – May 31, 2017

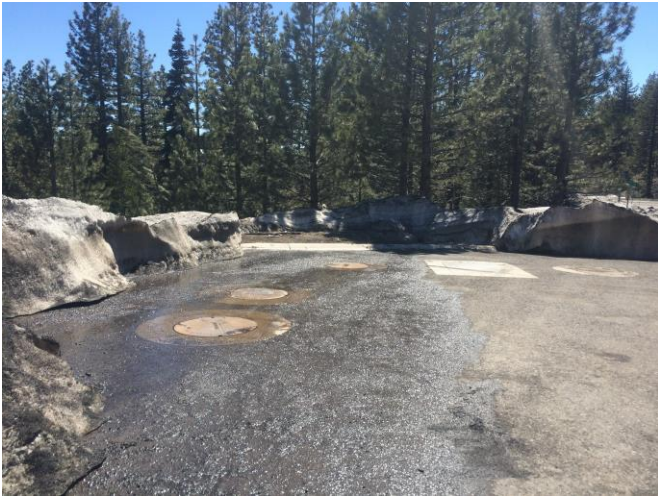
The spring season began on March 1, 2017 and ended May 31, 2017. Continuous turbidity was successful for the majority of the season, but the sensors were occasionally buried in sediment at the inflows. When available, turbidity data was interpolated from turbidity measurements taken on single samples in the lab for periods when sensors were covered and turbidity data was unreliable. Sediment was removed from sensors by hand regularly. Continuous flow was successfully sampled for the duration of the season. Overland snowmelt was observed flowing into the CO manhole cover, causing more flow at the CO as compared to CI during this time period. Sediment filled the splitter vault once during this time period, and the splitter vault, along with the Jellyfish and Contech MFS vaults were cleaned on April 20, 2017. There continues to be an ample source of sediment along the roadside and in the pullout above the monitoring station (Figure 2-4).

Figure 1: May 1, 2017, overland snowmelt flowing into CO manhole cover.

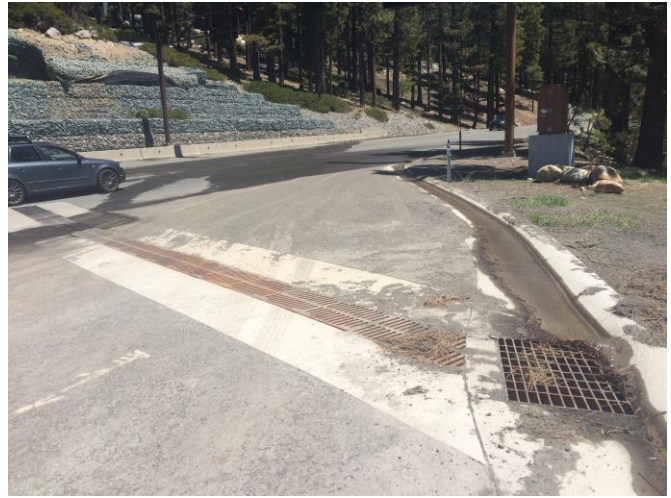
Figure 2: May 12, 2017 sediment on pullout and road. Snowmelt flowing into drop inlet.

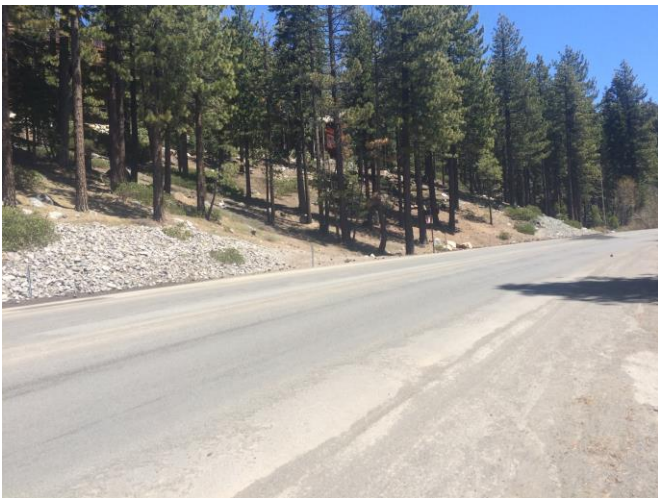
Figure 3: May 12, 2017 sediment on road.

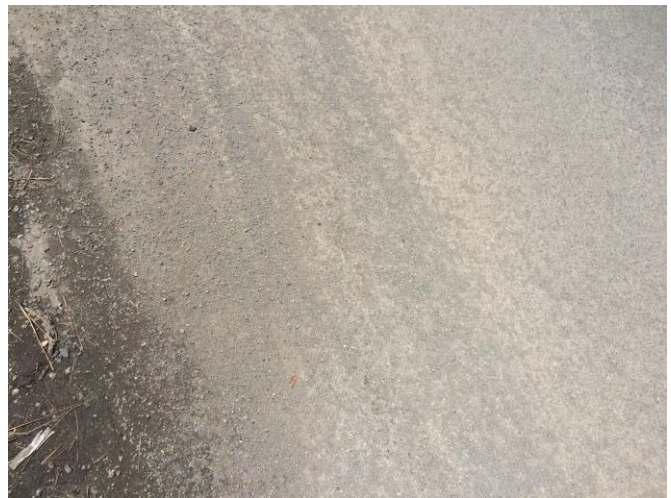
Figure 4: May 22, 2017 sediment on road.

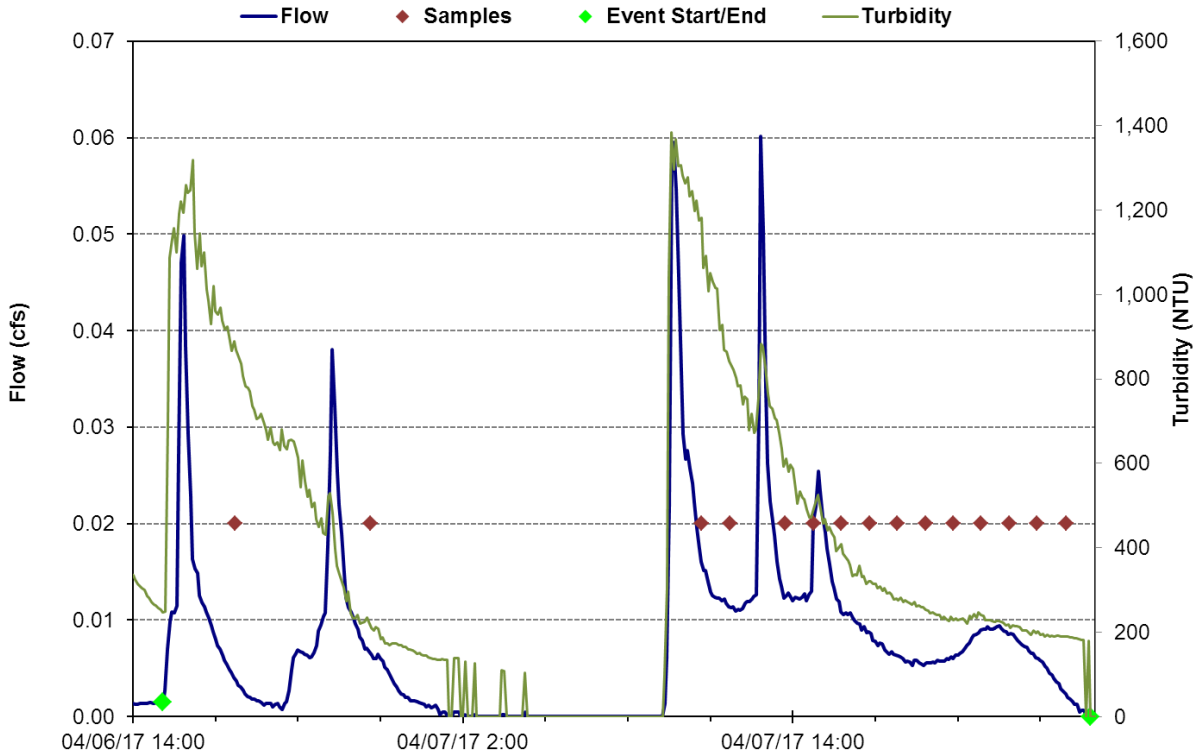
Contech MFS Outflow (CO) WY2017

Figure 8: Hydrograph, continuous turbidity and sample distribution at the Contech MFS Outflow for the 4/06/17 rain and snow event.

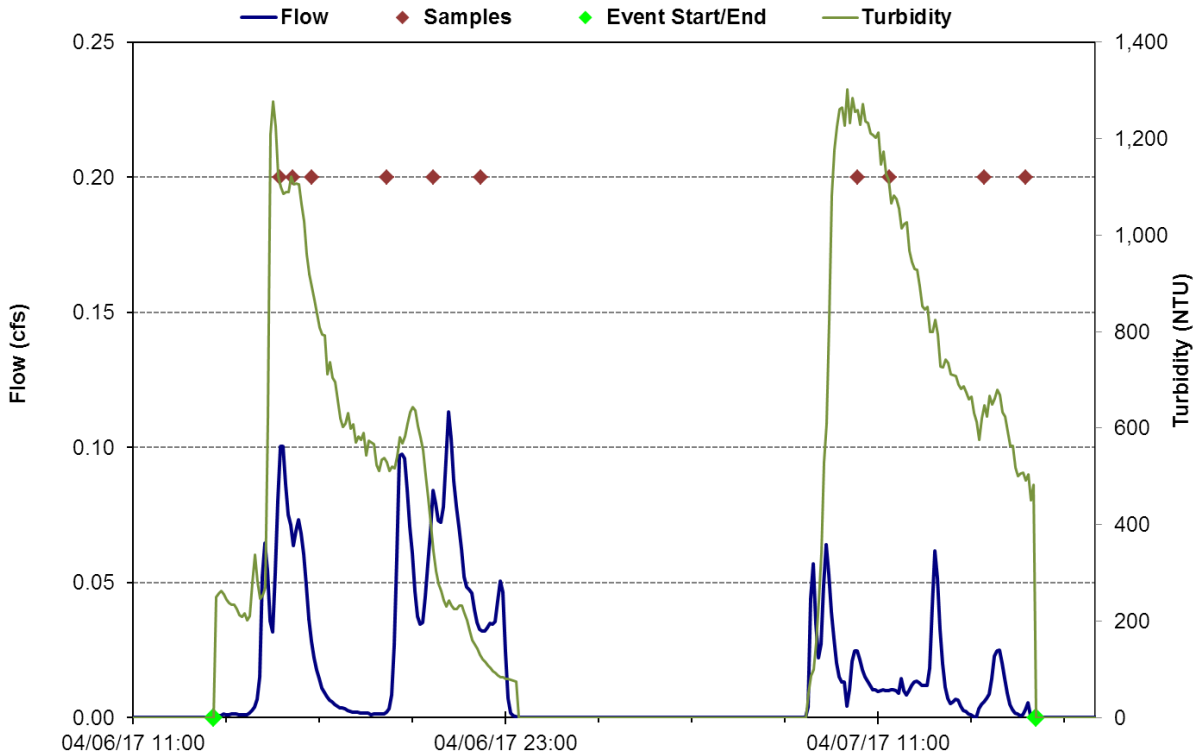
Jellyfish Outflow (JO) WY2017

Figure 10: Hydrograph, continuous turbidity and sample distribution at the Jellyfish Outflow for the 4/06/17 rain and snow event.

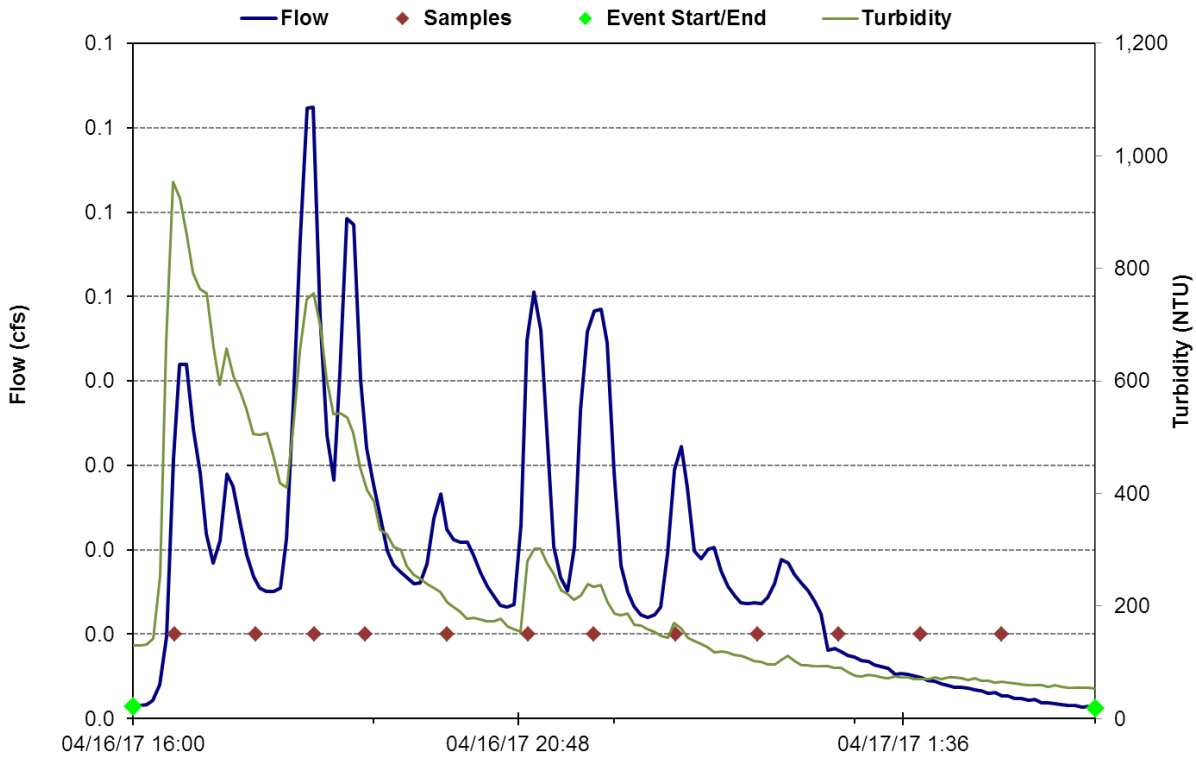
Contech MFS Outflow (CO) WY2017

Figure 12: Hydrograph, continuous turbidity and sample distribution at the Contech MFS Outflow for the 4/16/17 rain event.

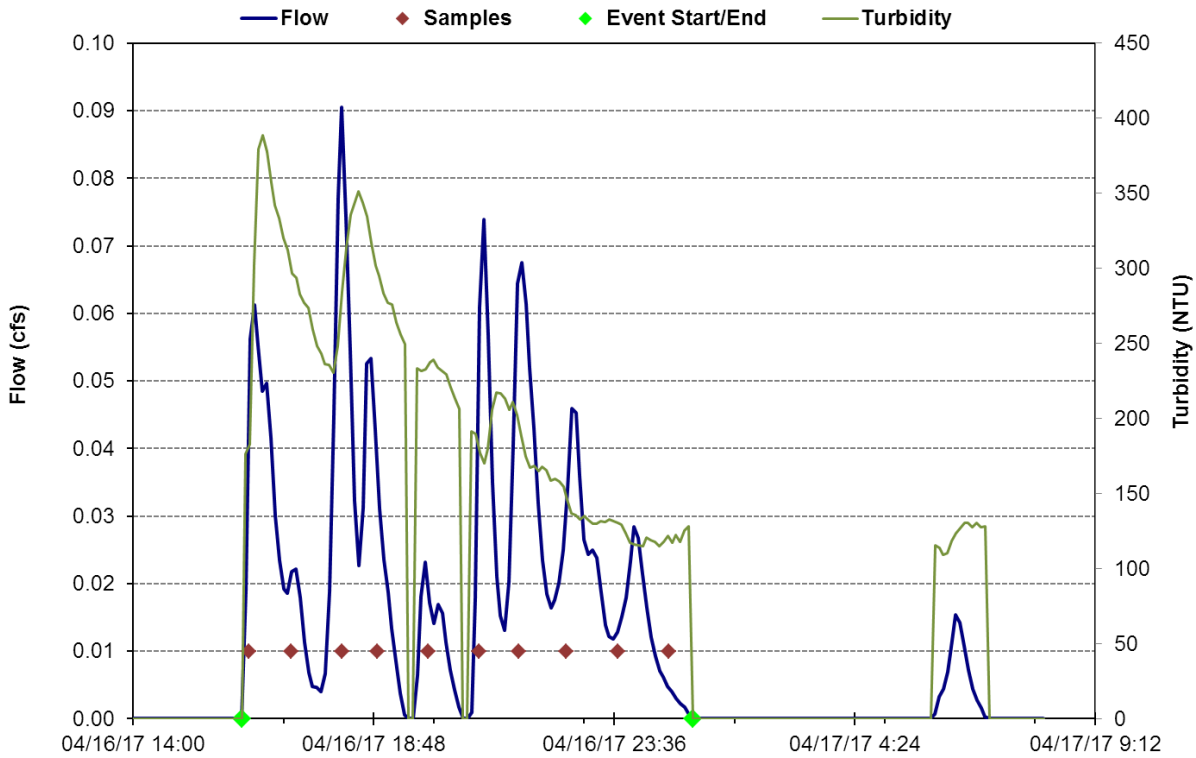
Jellyfish Outflow (JO) WY2017

Figure 14: Hydrograph, continuous turbidity and sample distribution at the Jellyfish Outflow for the 4/16/17 rain event.

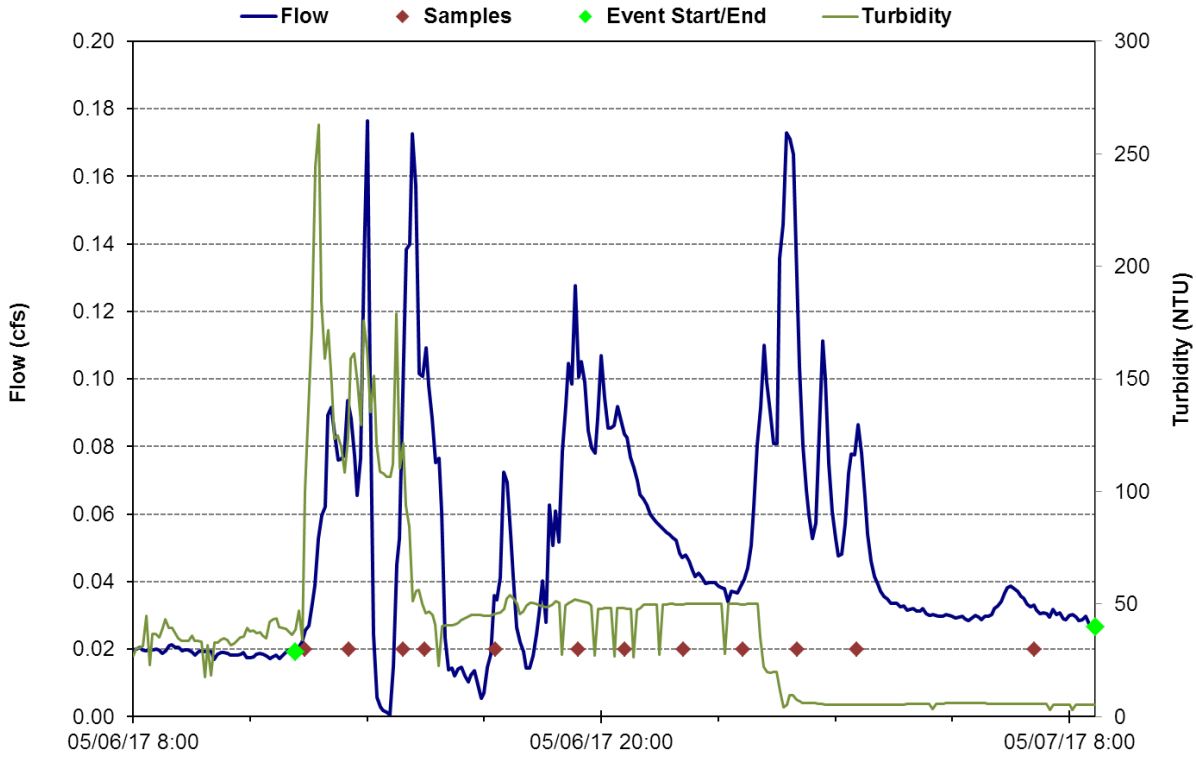
Contech MFS Inflow (CI) WY2017

Figure 15: Hydrograph, continuous turbidity and sample distribution at the Contech MFS Inflow for the 5/6/17 mixed rain and snow event.

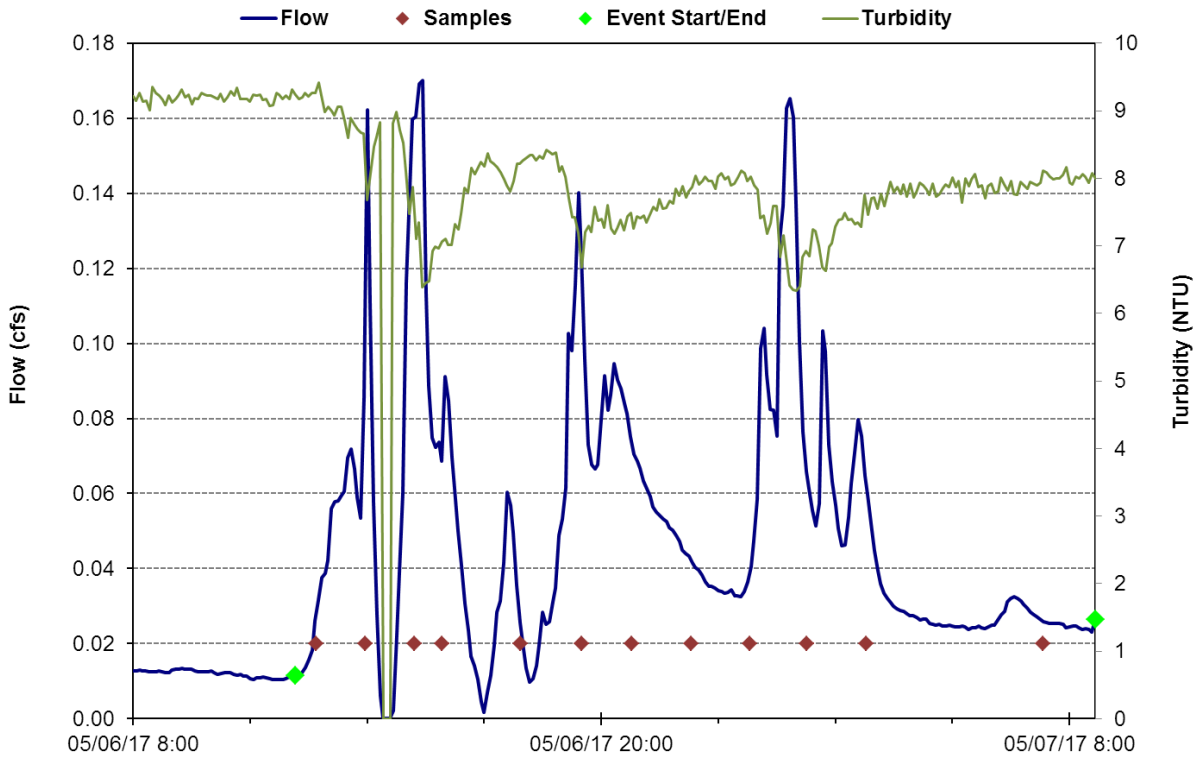
Jellyfish Outflow (JO) WY2017

Figure 18: Hydrograph, continuous turbidity and sample distribution at the Jellyfish Outflow for the 5/6/17 mixed rain and snow event.

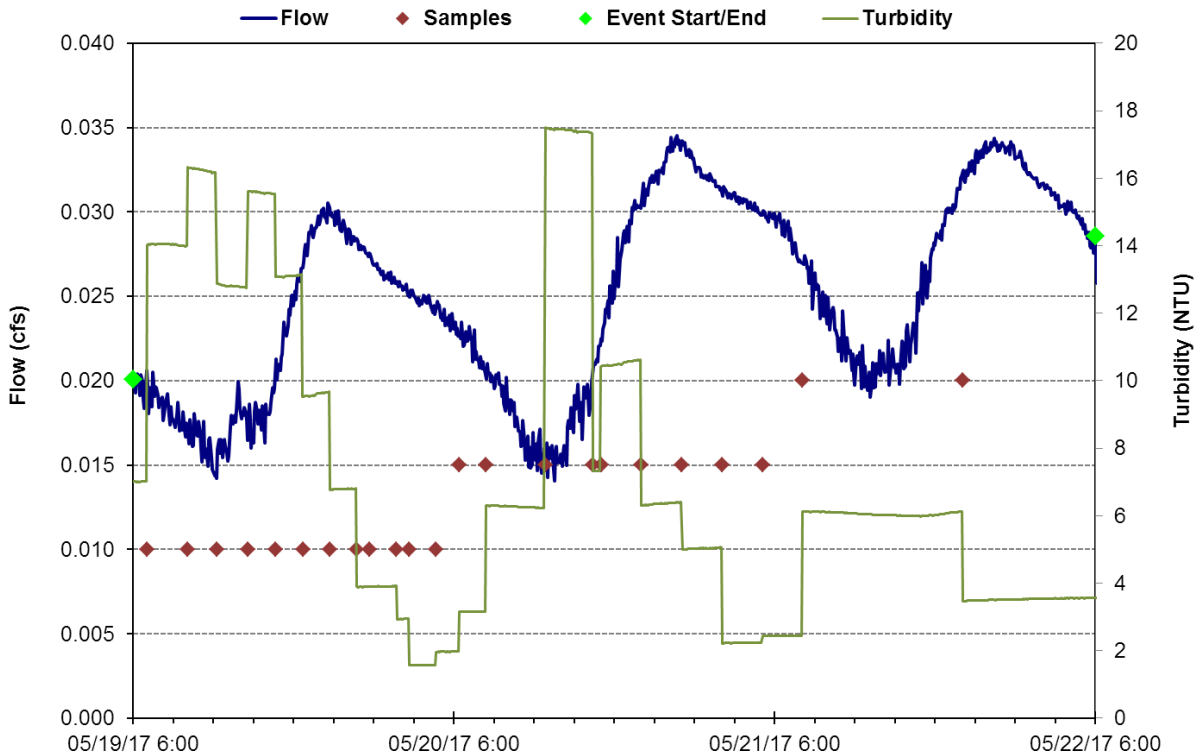
Contech MFS (CO) Outflow WY2017

Figure 20: Hydrograph, continuous turbidity and sample distribution at the Contech MFS Outflow for the 5/19/17-5/22/2017 non-event snowmelt sampling. Turbidity was adjusted by multiplier based on single sample turbidity.

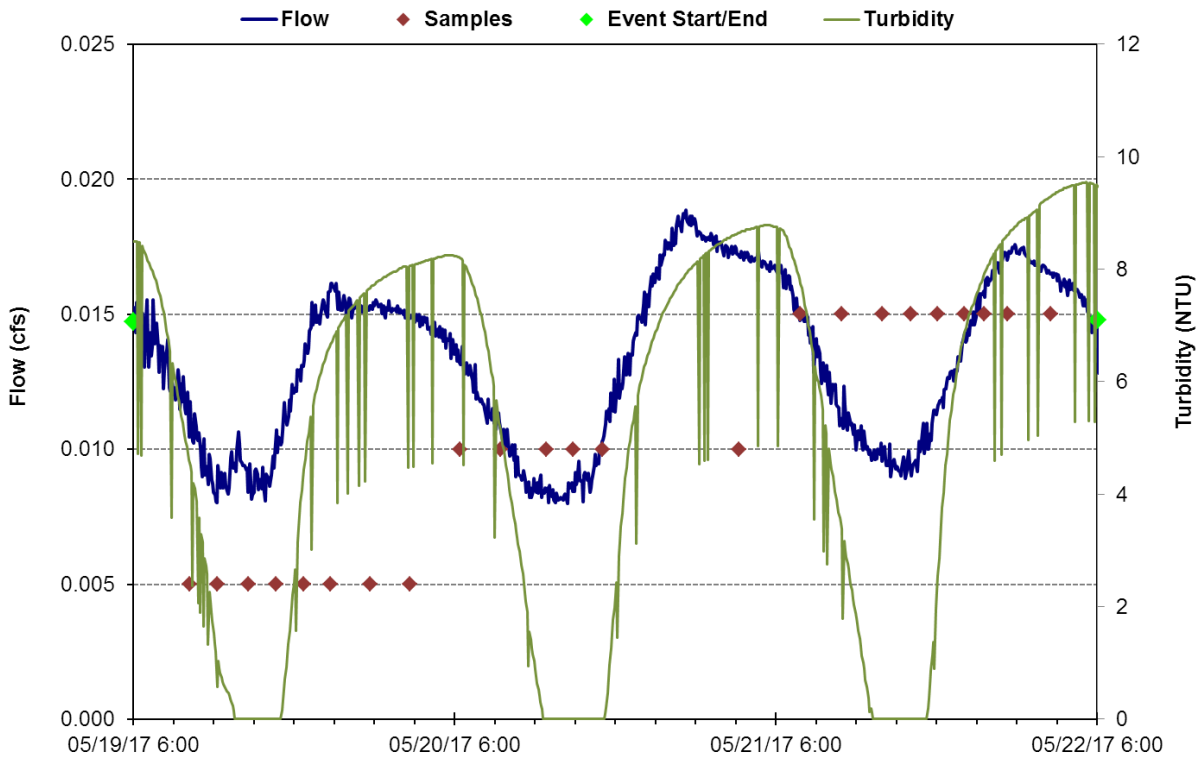
Jellyfish Inflow (JI) WY2017

Figure 21: Hydrograph, continuous turbidity and sample distribution at the Jellyfish Inflow for the 5/19/17-5/22/2017 non-event snowmelt sampling.

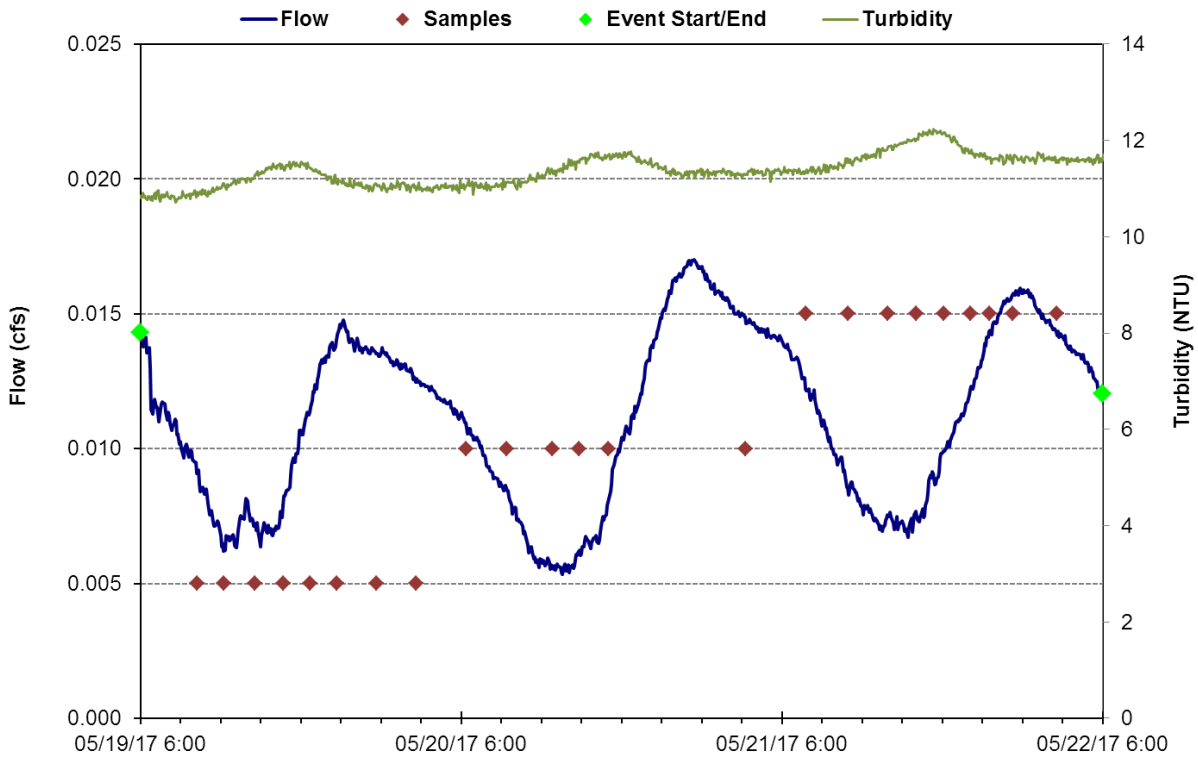
Jellyfish Outflow (JO) WY2017

Figure 22: Hydrograph, continuous turbidity and sample distribution at the Jellyfish Outflow for the 5/19/17-5/22/2017 non-event snowmelt sampling.
