INTRODUCTION

GENERAL INFORMATION ON STREAMFLOW AND LAKE LEVEL MAINTENANCE DAMS CONSTRUCTED UNDER WCB PROGRAMS

Name of Dam: Gilmore Lake

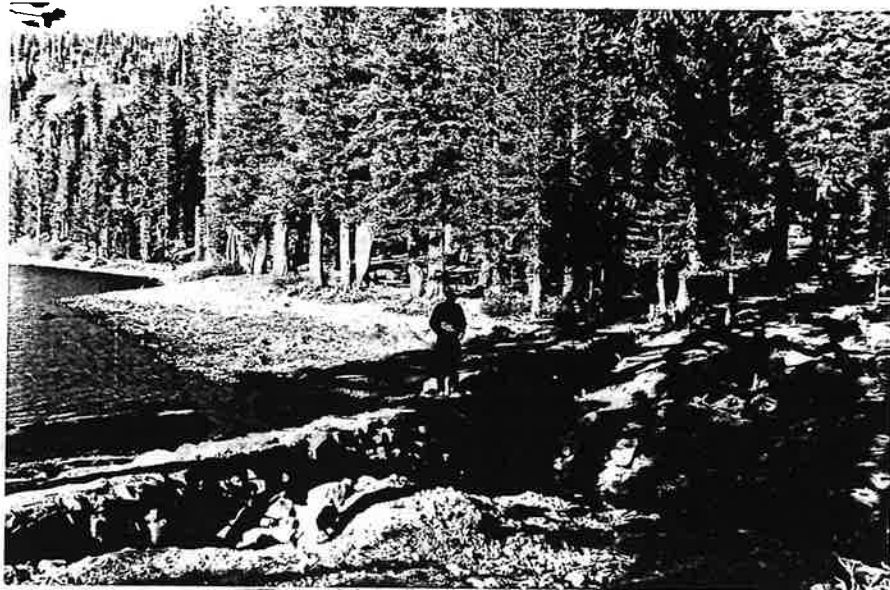
Dam Dimensions-Height: 5'

Length: 130'

Type of Construction: Rubble masonry

Valve: 12" Calco #101 slide headgate

The stream channel below the dam fills in occasionally and it should be cleaned out to fully utilize the storage in the lake.

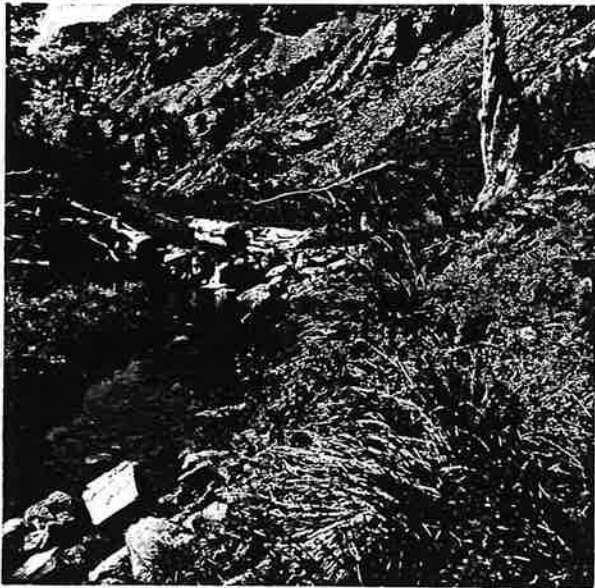
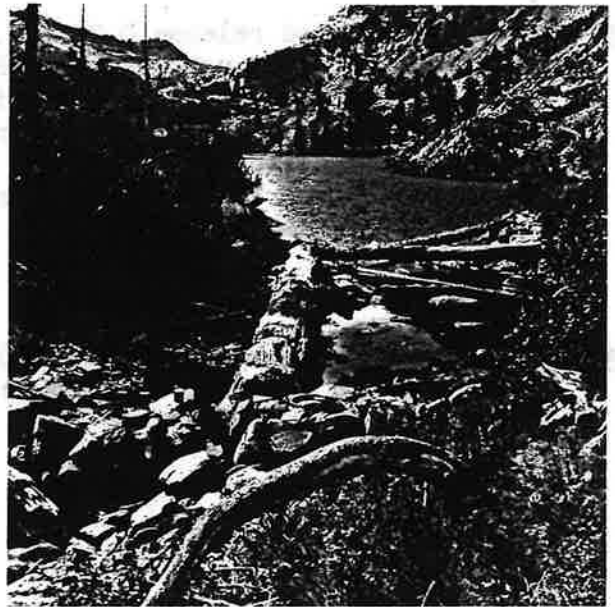
Name of Dam: Heather Lake

Dam Dimensions-Height: 4'

Length: 40'

Type of Construction: Rubble masonry

Valve: 12" Calco #101 slide headgate

Remarks: There is quite a debris problem above this dam. It is necessary to clean the logs and debris from above the dam about every two years.

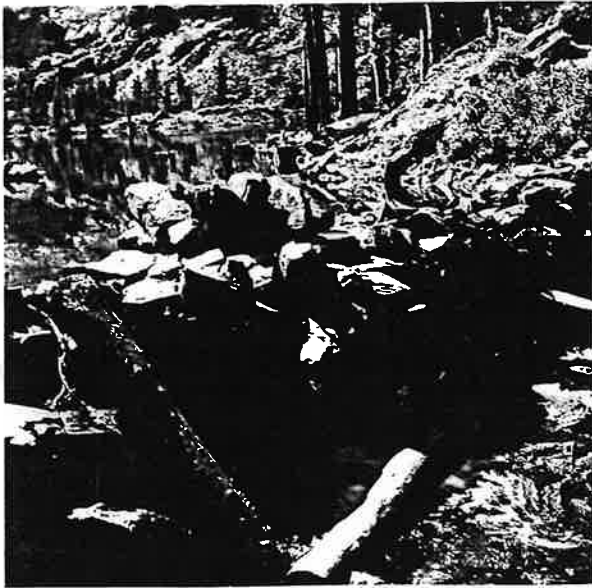
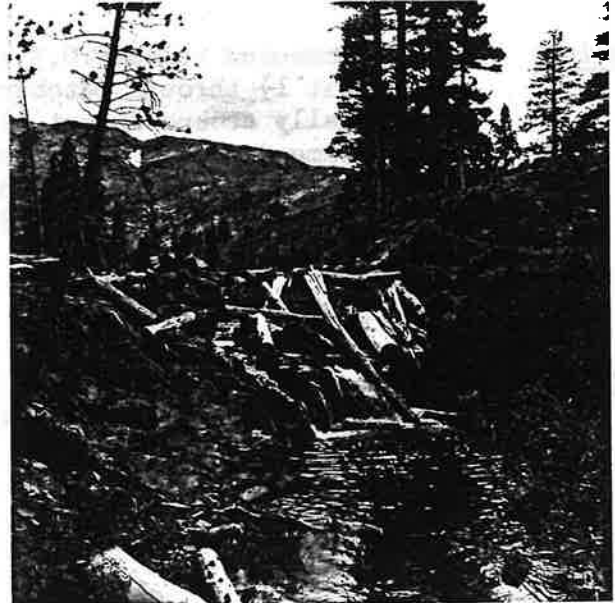
Name of Dam: Susie Lake

Dam Dimensions-Height: 3.5'

Length: 25'

Type of Construction: Rubble masonry

Valve: 12" Calco #101 slide headgate
